Subject: Letter Report
Riverdale Chemical Site, Chicago Heights, Illinois
Contract No. 68-W0-0129, TDD No. S05-0104-003

ENCLOSURE 1
PHOTOGRAPHIC LOG
(Eight Pages)

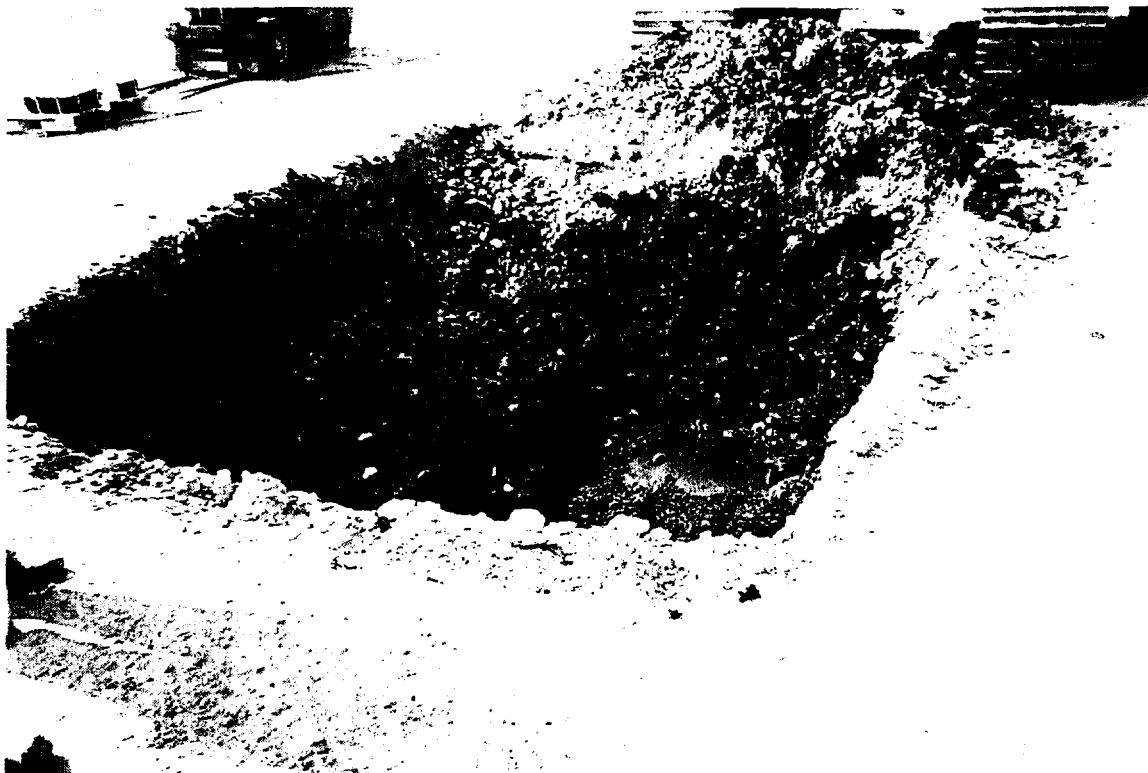
Photograph No. 3

Description: Water entering EX-3 2 feet below ground surface (bgs)

During the removal action, START observed that all but two pits (EX-3 and EX-14) were excavated to the U.S. EPA-approved dimensions. EX-3, which was to be excavated to 6 feet below ground surface (bgs), filled with water. After a failed attempt to pump out the water, RMT collected a soil sample from approximately 5 feet bgs to confirm that all contaminated soil had been removed. EX-14, which was to be 20 feet long, by 10 feet wide, and 6 feet deep, was only 12 feet long, by 6 feet wide, and 6 feet deep because of its proximity of overhead pipes and aboveground storage tanks. All the pits that were excavated to a required depth of 8 feet were marked at the bottom with orange fencing, and confirmatory samples were collected from the bottom of the pits.

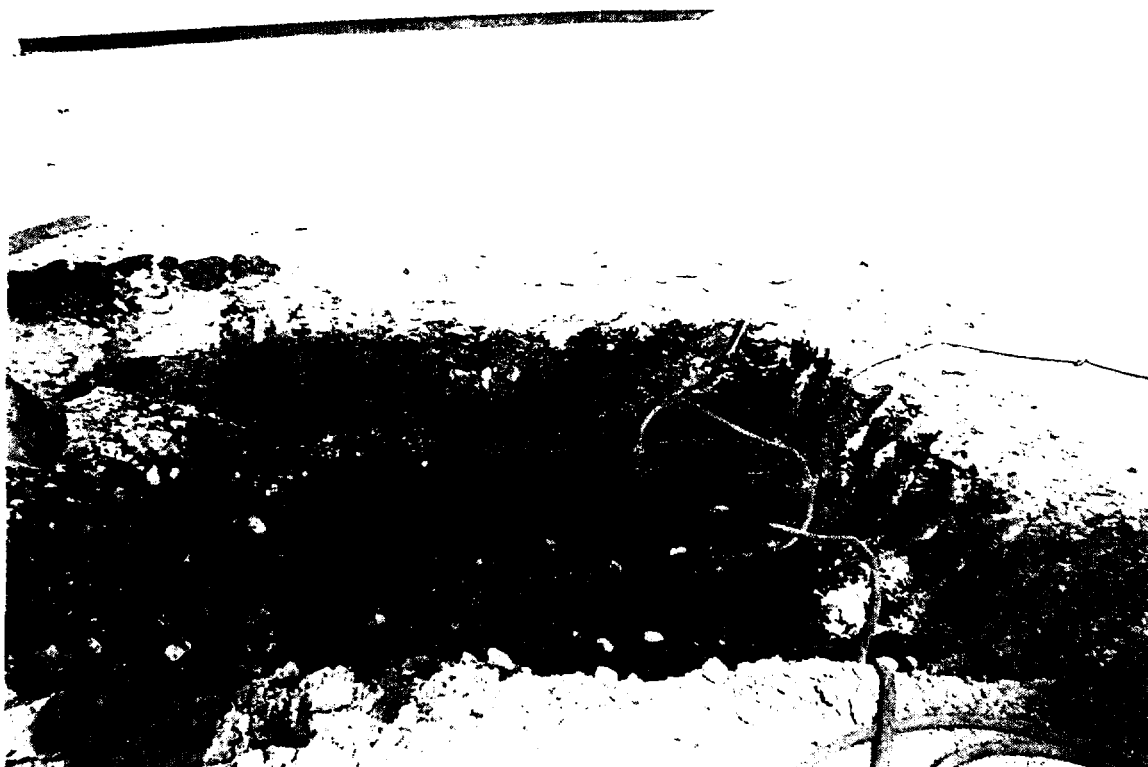
Photograph No. 4

Description: RMT pumping water out of EX-3 at 2 feet bgs

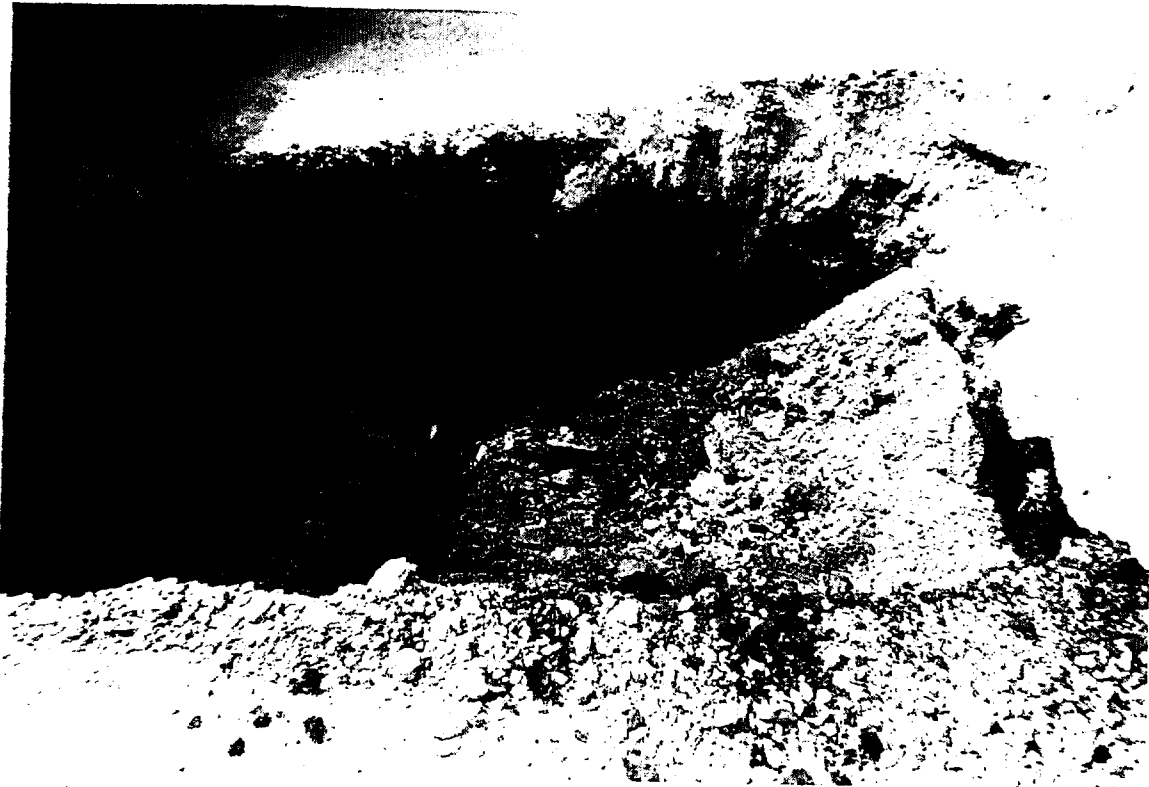
Photograph No. 5
Orientation: South
Description: Extent of EX-5

- 1010 - RMT began backfilling Ex-1 and continued excavation of Ex-3
- 1015 - Ex-3 excavator stopped once again because it filled with water again. Excavation of Ex-5 began.
- 1025 - Excavation of Ex-5 complete to 5 ft bgs. (See photo 5)
RMT also backfilling Ex-4 (See photo NE).
- 1035 - RMT backfilled Ex-5.
- 055 - RMT began pumping out water from Ex-3 again.
- 1105 - Excavation of Ex-6 began. Excavator will be to 8 ft.
- 1125 - RMT backfilled Ex-2. RMT also collected soil sample from bottom of Ex-6 at 8 ft depth.
- 1140 - Excavation of Ex-6 complete to 8 ft deep. (See photo W.) RMT placed ramp fence in bottom of Excavation.

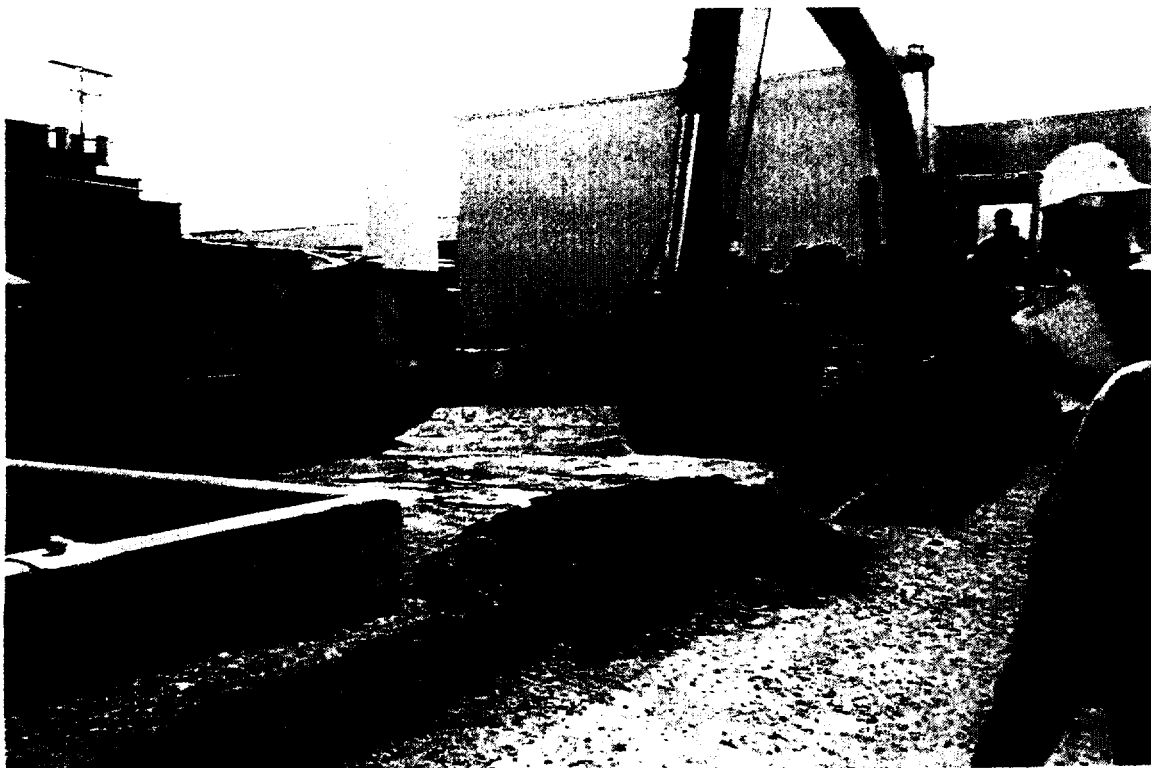
Photograph No. 10
 Orientation: East
 Description: Excavation of EX-12

- 0815 - START Lee Christensen on site. RMT completing Ex-11. RMT had completed Ex-9 and 10. Ex-9 was 8 ft bgs. RMT collected sample at Ex-9. Ex-10 went to a depth of 2 ft. Ex-11 went to 4 ft. bgs.
- 0825 - Excavation at Ex-12 began (See photo E). At approx. 4 ft. RMT uncovered a buried pipe with sludge/oil coming out. RMT will remove it and all surrounding soil and load it with all material going south. (See photo NE)
- 0845 - Ex-12 completed. Final dimensions 10'11" x 7'ft (See photo N).
- 0905 - RMT began Ex-13
- 0940 - Excavation of Ex-13. Photo E
- 0945 - Excavation of Ex-13 completed to a depth of 2 ft.
- [Signature]* 6-29-01
